# Sydney Opera House

Conservation Management Plan Overview

Team SIX

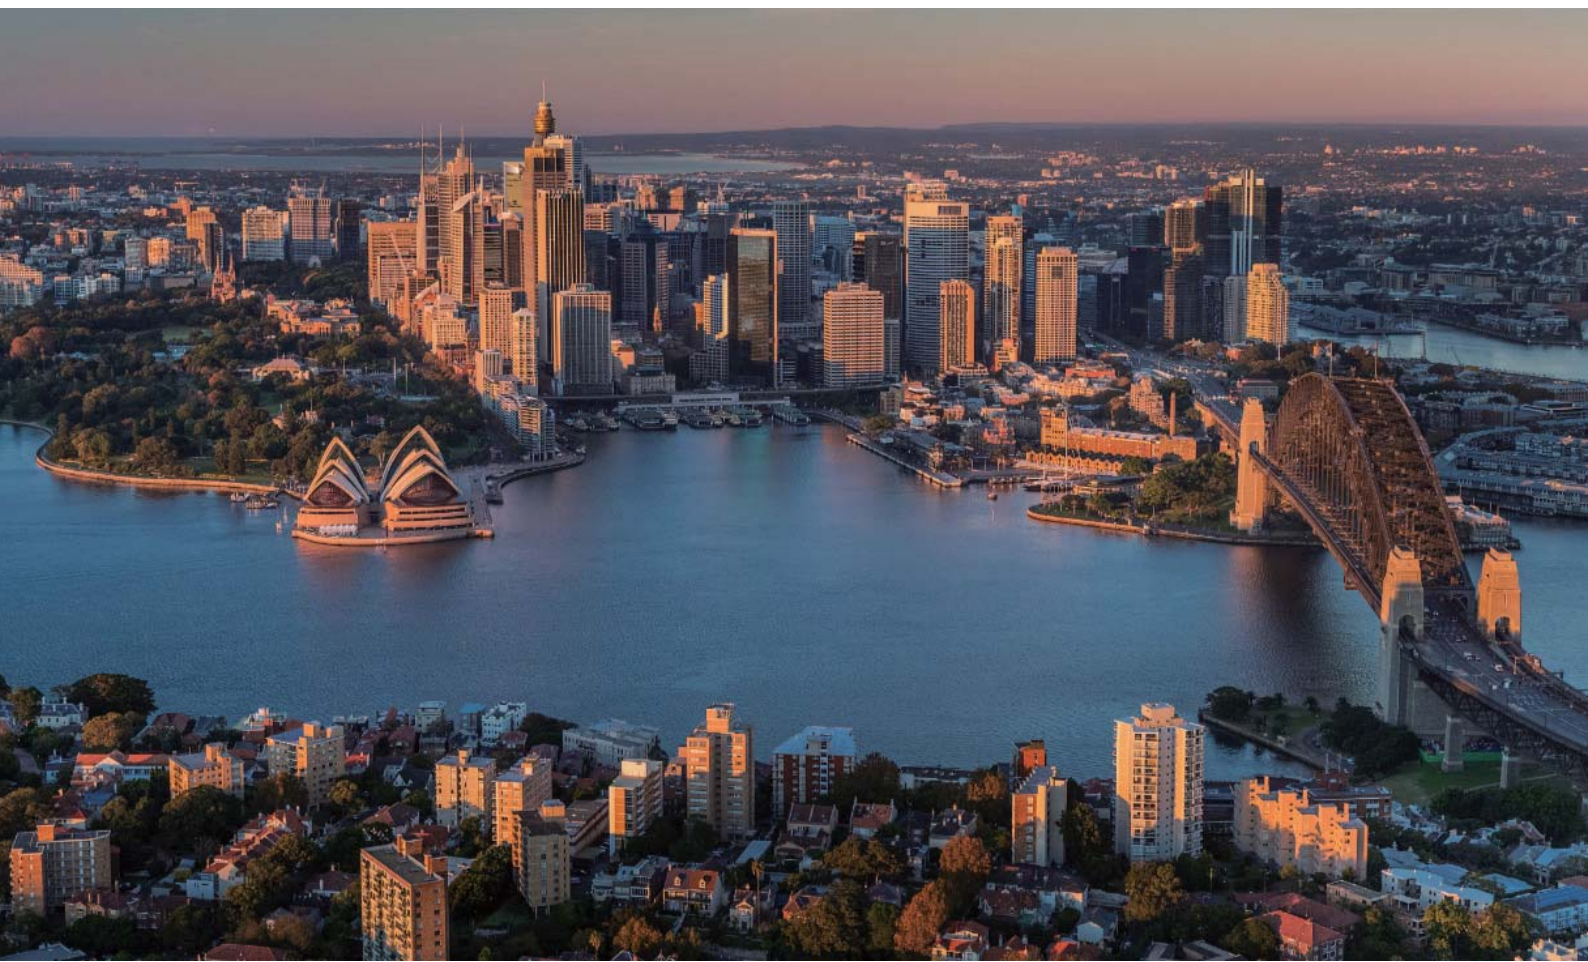
This area has formed from the deposition of alluvial materials scattered in the seawater and is not suitable to bear the weight of the opera house.

On the man-made peninsula in the southern part of Sydney Bay, with a total area of 2.2 hectares, it is supported by 588 concrete piers settled 25 meters below sea level. The buildings, with a length of 183 meters and a width of 120 meters, occupy 1.8 hectares of this area.

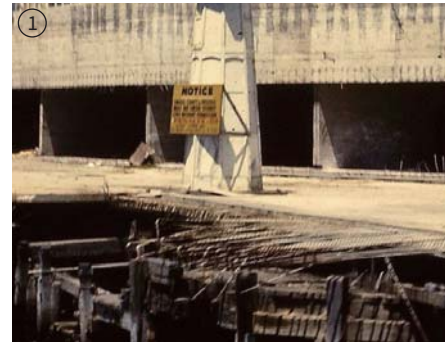
The Opera House is built on a narrow peninsula of land on the south shore of Sydney Harbour. The Western Broadwalk and Northern Broadwalk rest on steel reinforced concrete piers, which are embedded into the harbour floor. Granite aggregate slabs are used to clad the Broadwalks. **(Figure 1)**

歌劇院站立於最下方的步道平台，由於雪梨歌劇院座落於雪梨港南岸的狹窄半島上，因此結構部分由鋼筋混凝土澆灌並嵌入港口的地層（圖 1）。

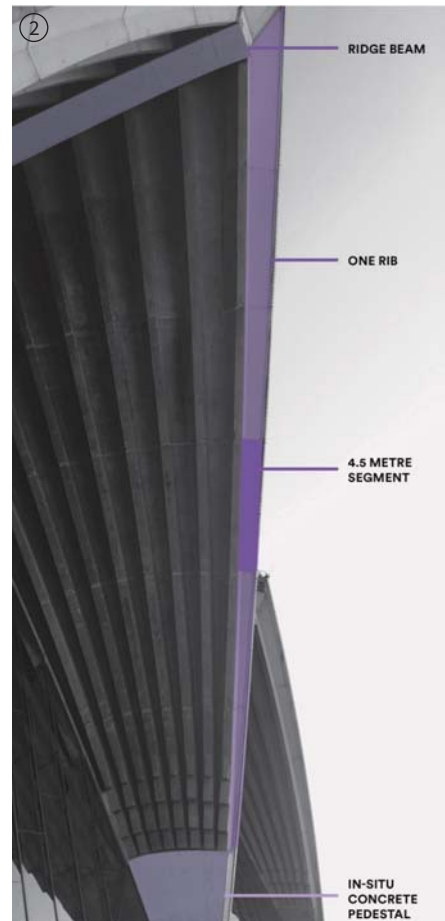
The points from which the sail ribs rise from the podium, and connect to the foundation columns, are known as the Pedestals. **(Figure 2)**

The Pedestals are made of reinforced concrete, cast in-situ, and can be seen on the building's exterior below the line of ceramic tiles.

歌劇院主體由折扇般的結構構成，其中分為兩部分，帆肋從平台升起並連接到柱礎的部分稱為基座（圖 2），基座由現場澆灌的鋼筋混凝土製成，暴露於外部的磁磚線以下。

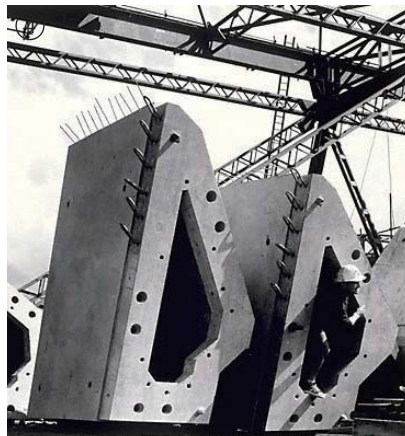
During construction of the Opera House, the pre-cast rib **(Figure 4)** sections of the sails were cast with ducts to carry the steel stressing cables. In all, 4100 individual ducts with a total length of around 113 kilometres (70 miles) were created.

而肋帆部分則是由預鑄的鋼筋混凝土部件組成（圖 4），每個高度的斷面都不盡相同，且內部以空心管道乘載鋼應力的纜索，整個歌劇院共有 4100 條獨立管道，總長度約為 113 公里 (70 英里)。

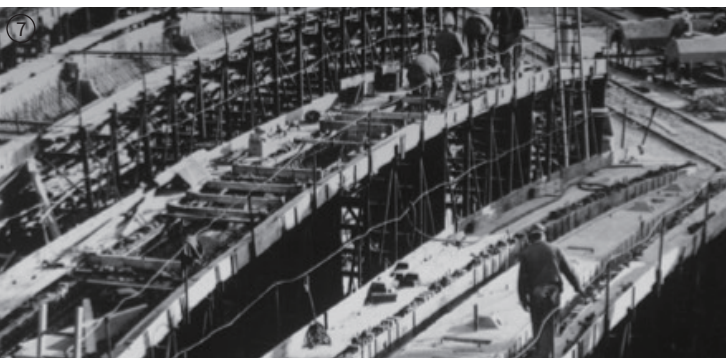
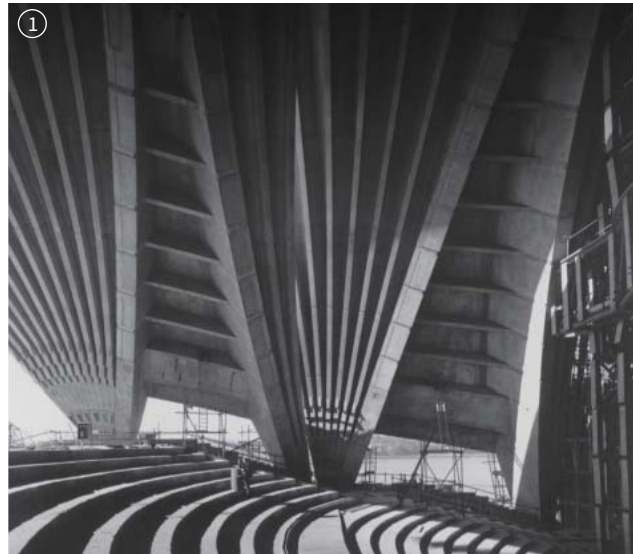
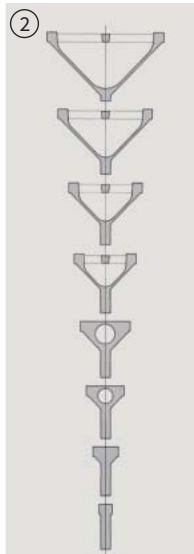
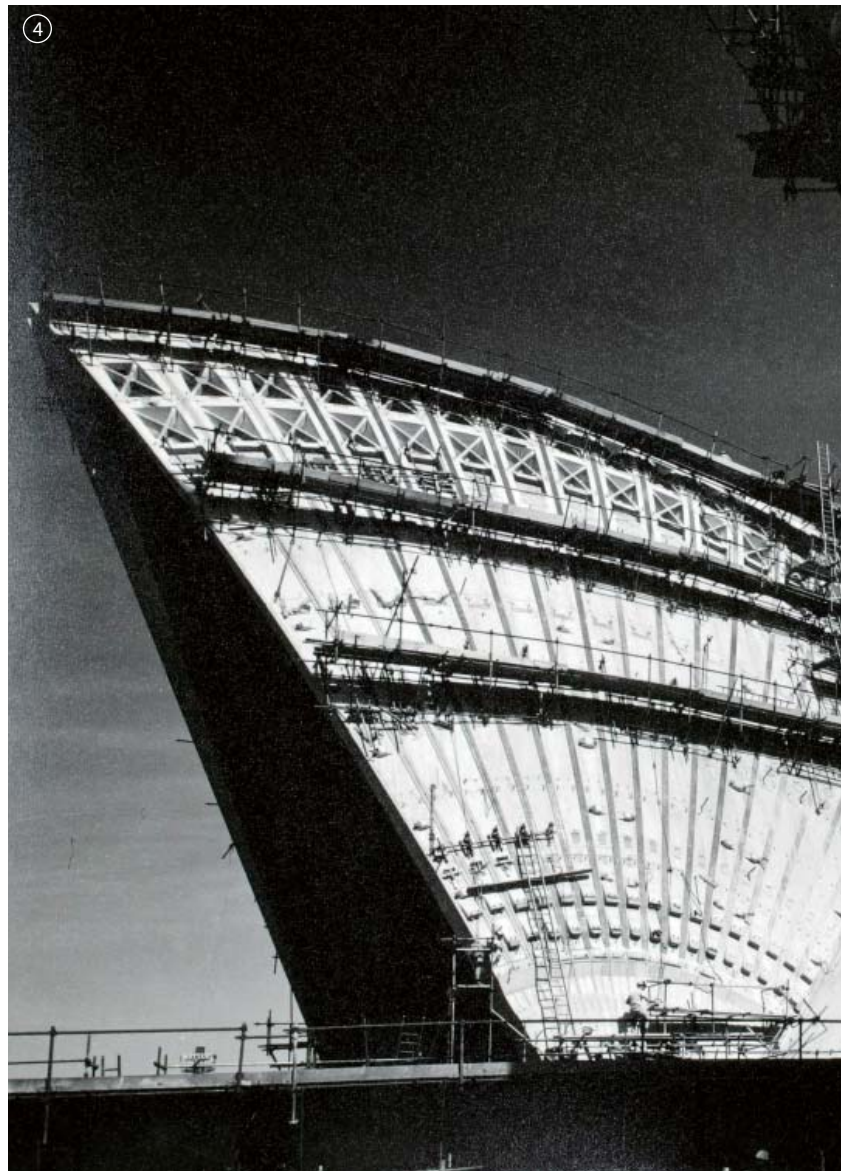
- Ove Arup designed folded concrete beams to support the podium structure (Figure 1, 2)

- One of the first buildings in the world to make use of computers in design (Figure 3)

- An adjustable mounting and assembly arch was invented for the project. This removed the need for mass scaffolding to support the structure during construction. (Figure 4, 7)

- The Opera House is the first large-scale example of glass used as a structural load bearing material in a building. (Figure 5, 6) (圖 5,6)

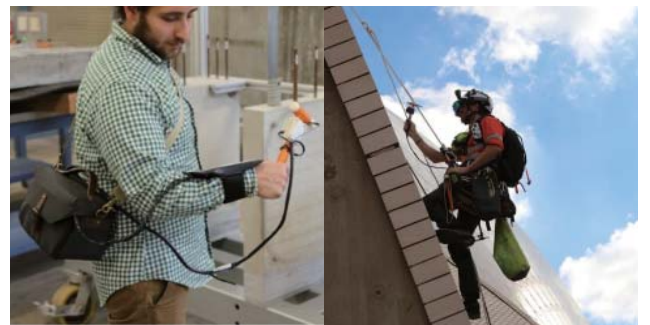
Practical investigations and non-destructive testing methodologies were developed based on the identified knowledge gaps and priorities. These included condition assessment of the concrete under the tile lids, studies on the environmental impacts on the roof pedestals, and inspection of the concrete in the Northern Broadwalk under-structure.

根據已知的知識差距和優先事項執行了實際調查和非破壞性的檢測方法。其中包括對混凝土下方的磁磚狀況進行評估、研究環境對屋頂基座的影響，並檢查北邊步道平台的下層混凝土結構。

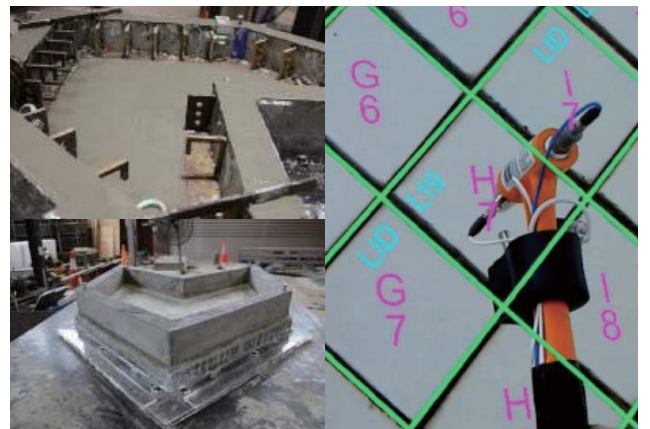
### Tile Lids / 磁磚座

- Ground penetrating radar  
探地雷達
- Ultrasonic pulse echo imaging  
超音波脈衝回波成像
- Robot for inspecting the sails  
檢查肋帆的機器人
- Remote-sensing vibrometer  
遙感測振儀
- Vibration speakers  
振動揚聲器

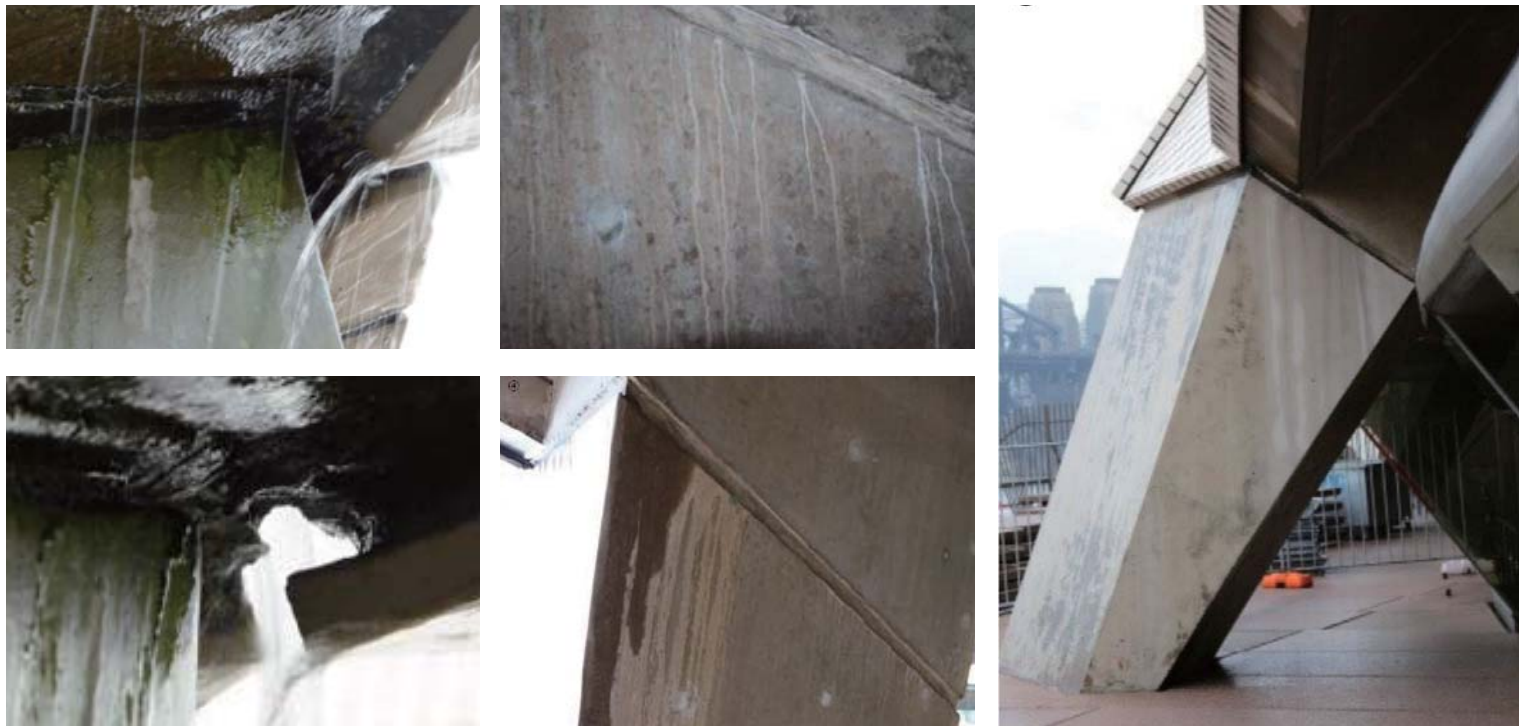
- After reviewing recent inspection reports, it was determined that reductions in surface thickness and minor carbonation and chloride ingress did not represent a threat to the structural condition of the pedestals.  
審查最近的檢查報告後，確定表面厚度的減少、輕微的碳化以及氯化物的滲入並不會對基座的結構狀況造成威脅
- Some areas of decreased coverage in specific localized areas, which may be treated on a case-by-case basis. In the initial part of this work, the main aim was to reduce, if not completely eliminate, the rain runoff reaching the back faces of the pedestals.  
某些局部覆蓋率下降的區域可以根據實際情況進行處理。這個項目的最初目標是減少（如果不能完全消除）基座背面的雨水逕流。

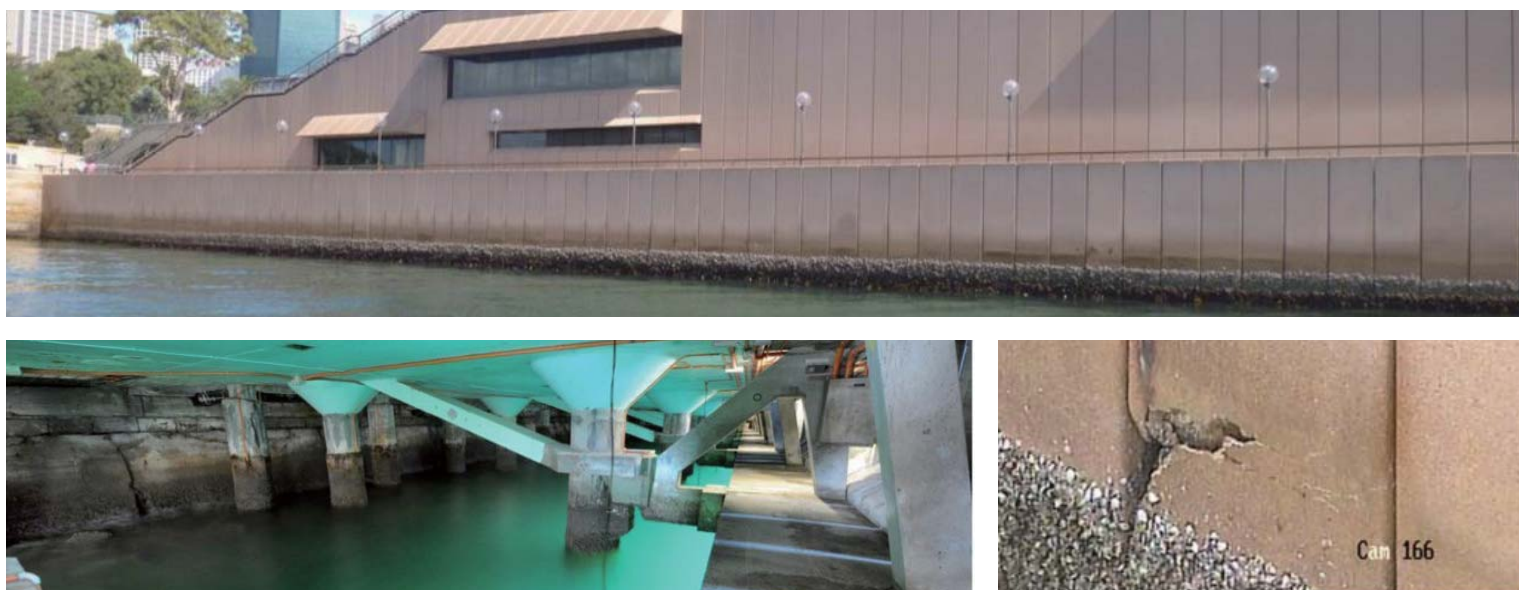
- While extensive inspection and repair works have been carried out on the Northern Broadwalk before the comprehensive study in August 2015, the records of these activities were limited. Site visits performed by the University of Sydney team in August / September 2015 visually inspected selected beams and columns to provide a framework for monitoring and documenting typical structural elements in this area. This was not further pursued by the University team once it was identified that Arup had established a similar framework for their regular inspections.  
雖然在 2015 年 8 月進行全面的研究前，已對北邊的步道進行廣泛的檢查和修復工作，但留下的紀錄有限。雪梨大學團隊於 2015 年 8 月至 9 月進行了實地考察，親眼檢查了選定的梁和柱，為監測和紀錄該區域的典型結構元素提供了一個框架，但並未進一步推進，直到結構團隊建立了類似的定期檢查框架。
